**INTERNATIONAL TSUNAMI SURVEY TEAM
REPORT ON FIELD SURVEY IN MADAGASCAR
OF THE 2004 SUMATRA TSUNAMI**

Report on ITST Field Survey, Madagascar, July–August 2005

An International Tsunami Survey Team (ITST) visited Madagascar from 24 July to 06 August 2005, in order to survey the effect of the 2004 Sumatra tsunami on the island.

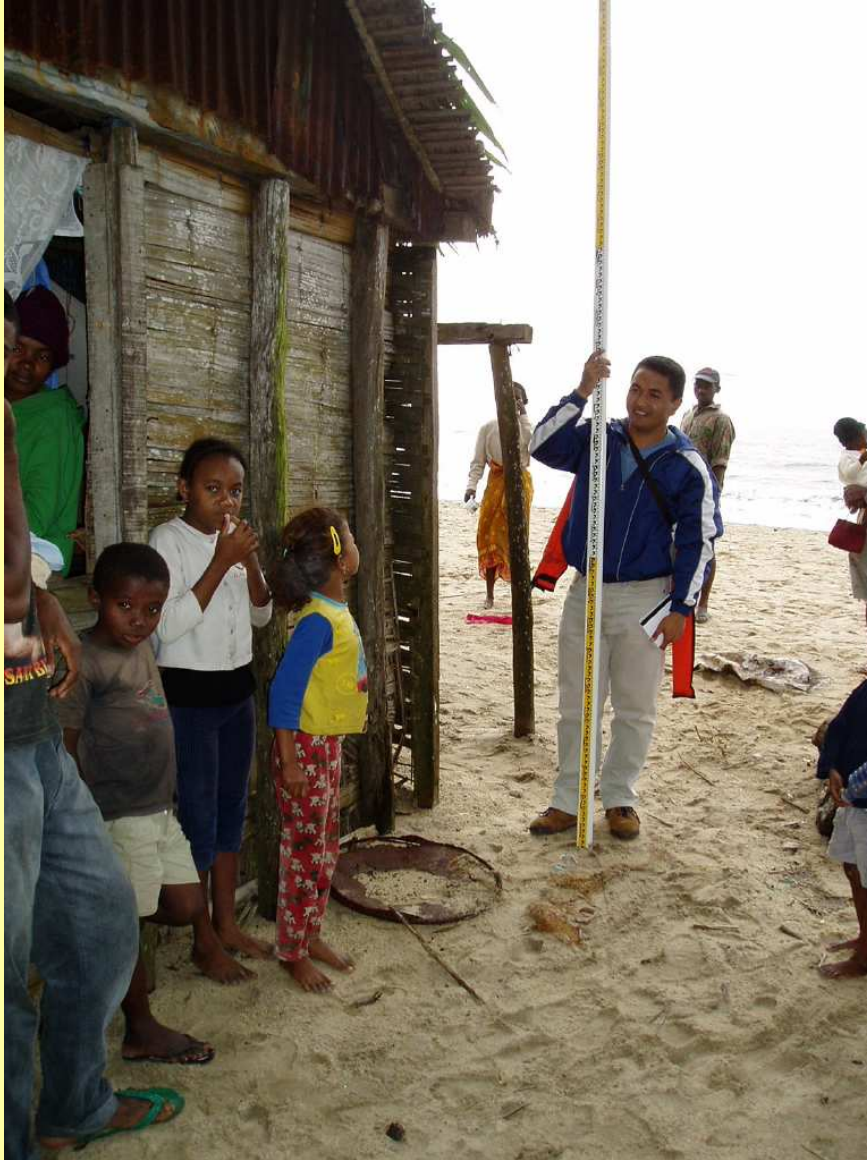
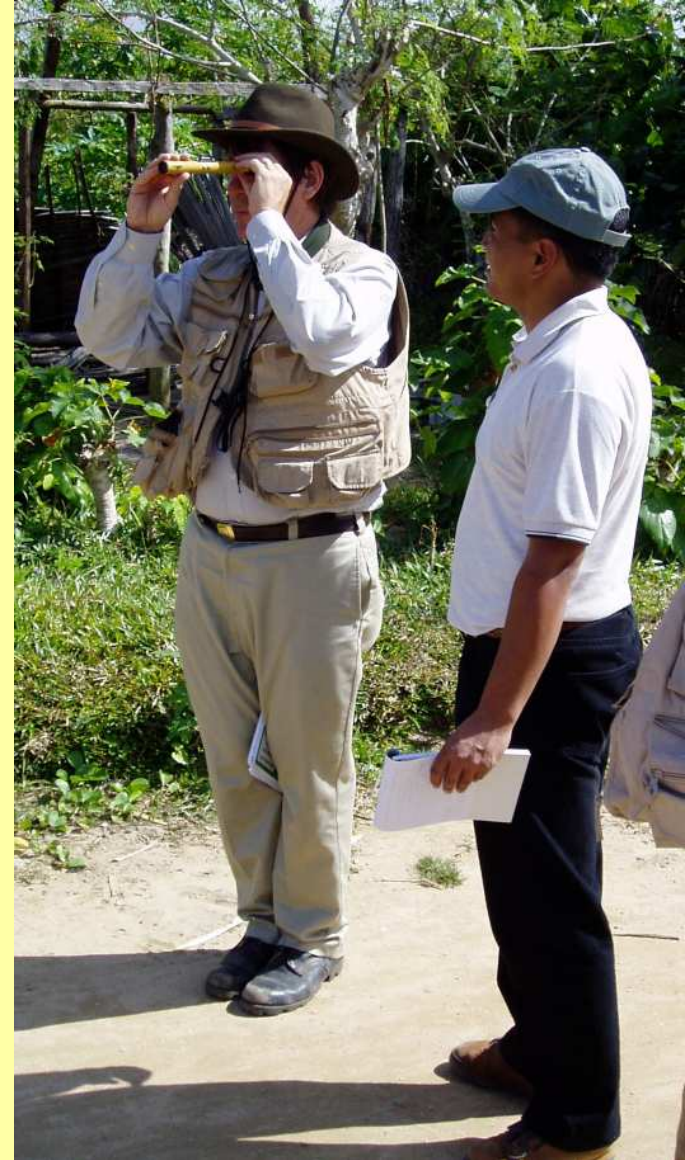
Figure 1. Measurement of flow depth and run-up by standard topographic methods using a leveling rod (*Left*; Site 22a at Soanierana-Ivongo) and an eye level (*Right*; Site 1 at Amdingozabe).

Flow depth and run-up measurements were made by optical means, using eye levels and surveying rods (Figure 1); inundation measurements were taken by differential GPS (Figure 2). The exact dates and times of the individual surveys were recorded, in order to later effect tidal corrections, which allow to relate flow depth and run-up measurements to the exact sea level at the time of arrival of the tsunami wave.

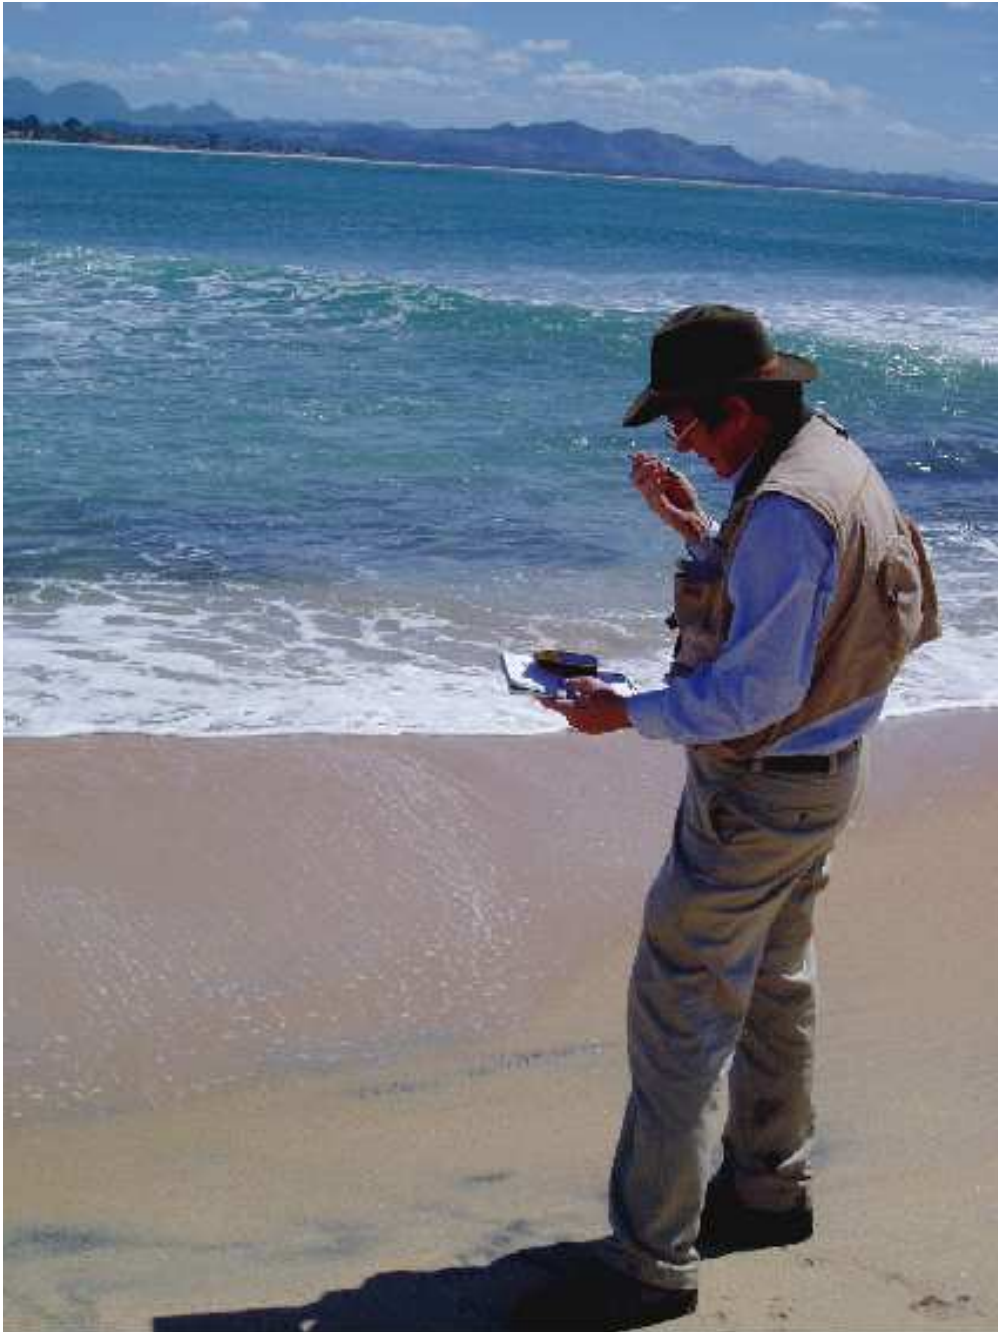
Figure 2. Example of GPS measurement, allowing precise surveying of the site (in this case Site 6, on Ampandrozonana Beach in Sambava), and in addition, a computation of the inundation parameter, by differential GPS surveying.

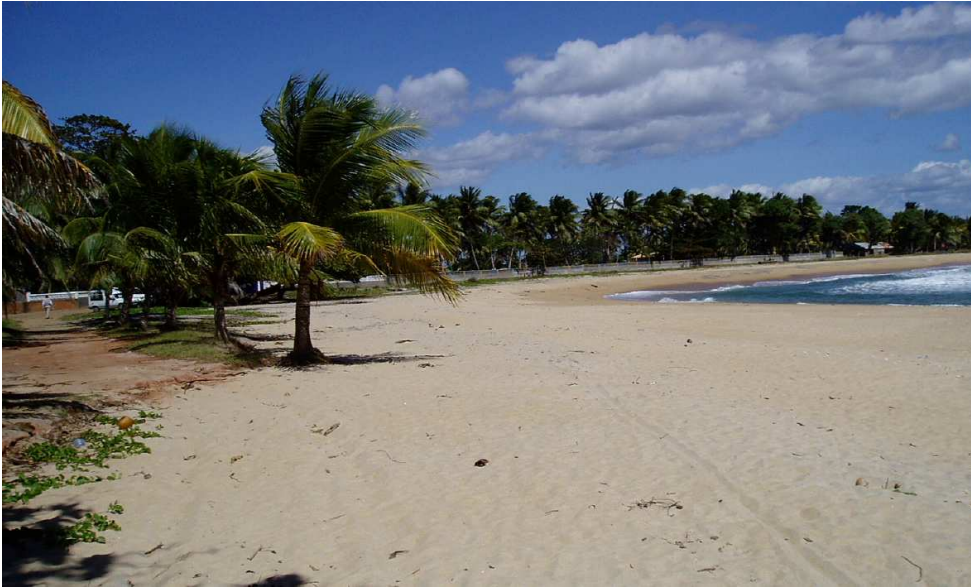
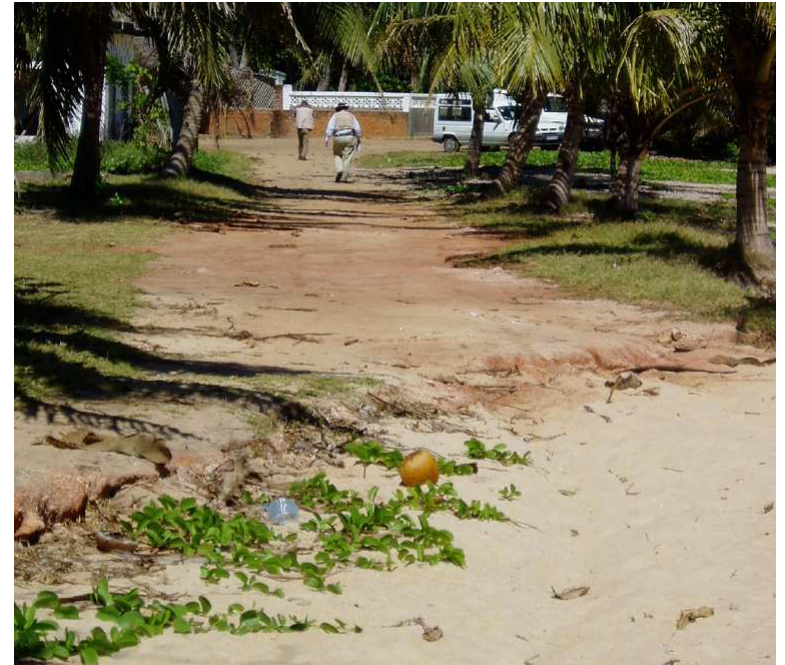
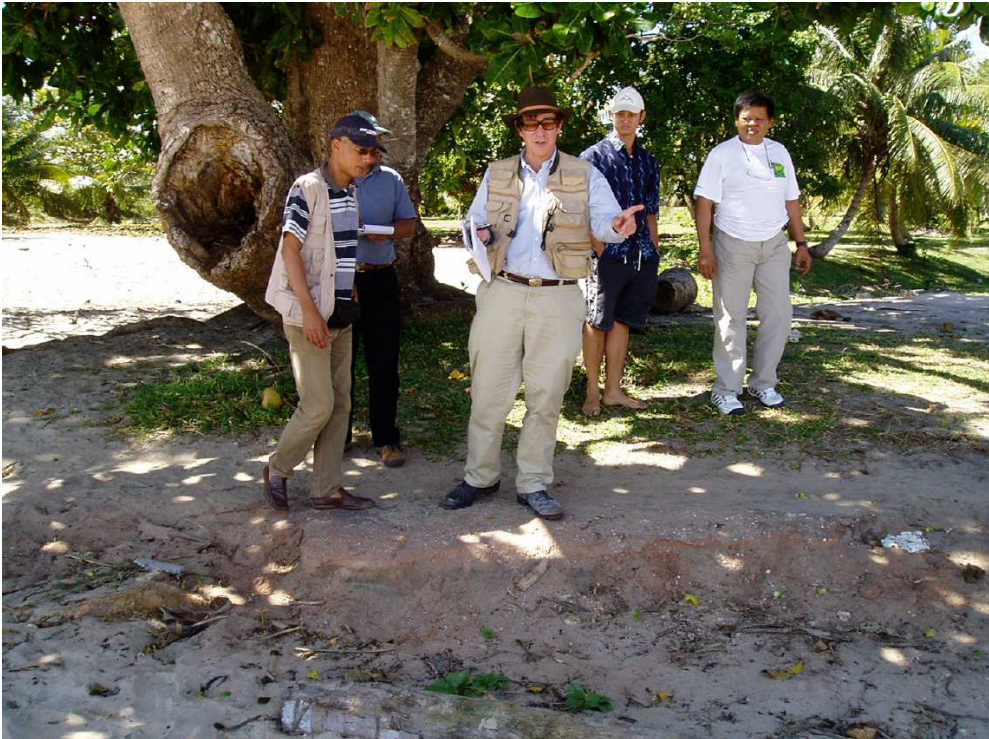
4. Except for the tragic drowning of a 12-year old boy in front of his parents at Site 28, the most spectacular effects from the tsunami were the disintegration by scouring of a 40-m segment of graded road along the Ampandrozonana Beach at Sambava (Site 6; Figure 4), and the development of an eddy system in the port of Toamasina (Tamatave; Site 16), described in detail below. Damage to small boats was minimal, especially as compared to the case of the ports on Réunion Island.

Figure 4. Scouring of a road along Ampandrozonana Beach in Sambava (Site 6). *Top Left:* General view of the beach, with the eroded road segment to the left, 71 m away from the water line. *Top Right* and *Bottom:* Close-up of the scouring. Note the advance of the beach, identified by sand deposits, over the previous location of the road.

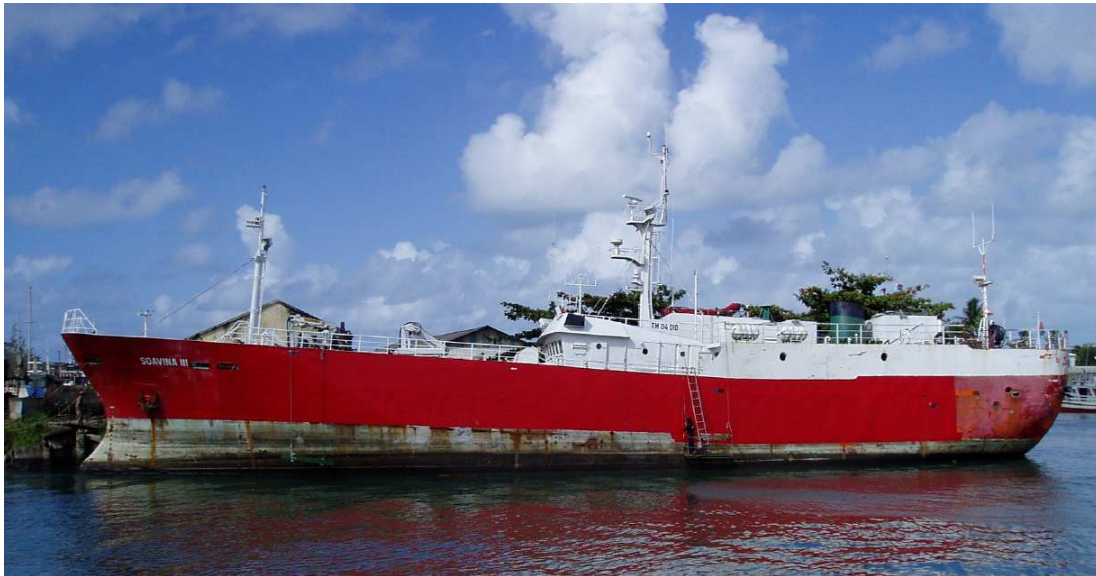
An extremely singular phenomenon took place in the port of Toamasina, as related to us by Captain Jami Injona, a port pilot, and confirmed (in part) by Captain Talainy, the skipper of the freighter *Ludovic*. The latter explained to us that as early as 12:30 local time, his boat had been subject to turbulent activity in the harbor, as it lay moored to the wharf. Captain Injona then reported a considerable amplification in the strength of the currents in the harbor (but not in the height of the waves), starting at 19:00 (GMT+3), and culminating in the 50-meter freighter *Soavina III* breaking its mooring, and wandering through the harbor for the next 3 hours, with the harbor pilots unable to control her from their tugboats. The ship eventually grounded on a sand bar, along the beach of a nearby water-sports center (Site 17; Figure 5). Miraculously, this "ghost" vessel did not collide with other ships or with harbor structures.

Figure 5. *Top:* The 50-m freighter *Soavina III* photographed on 02 August 2005 in the port of Toamasina. *Bottom:* Captain Injona uses a wall map of the port to describe the path of *Soavina III* from her berth in Channel 3B (pointed to on map), where she broke her moorings around 7 p.m., wandering in the channels up to the location of the red dot, before eventually grounding in front of the Water-Sports Club Beach (white dot; Site 17).
